# Advanced Gas Turbine

## Technology Project

### 1984 Annual Report

#### Allison

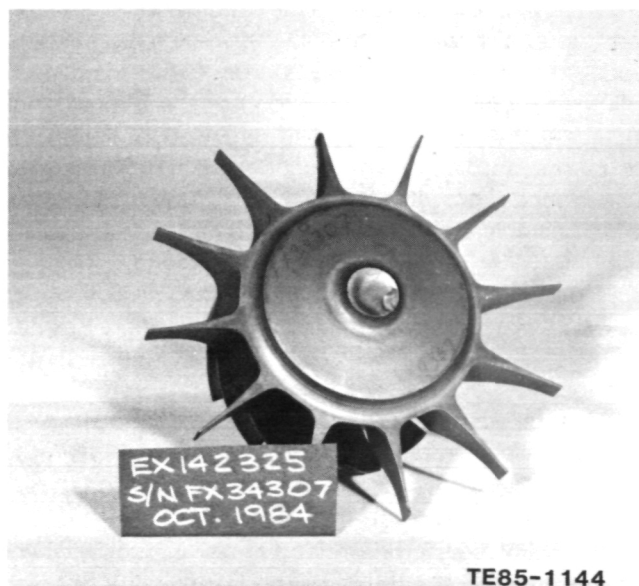
**Figure 75. Fracture on rotor S/N FX34307 (first assembly, modified attachment design).**

- remote failure modes
    - overspeed
    - rub
- } no evidence
